ATM SEC CAMERA TUBE SPARES PROGRAM

NAS 8-29063

FINAL REPORT

APOLLO TELESCOPE MOUNT  
SEC CAMERA TUBE SPARES PROGRAM

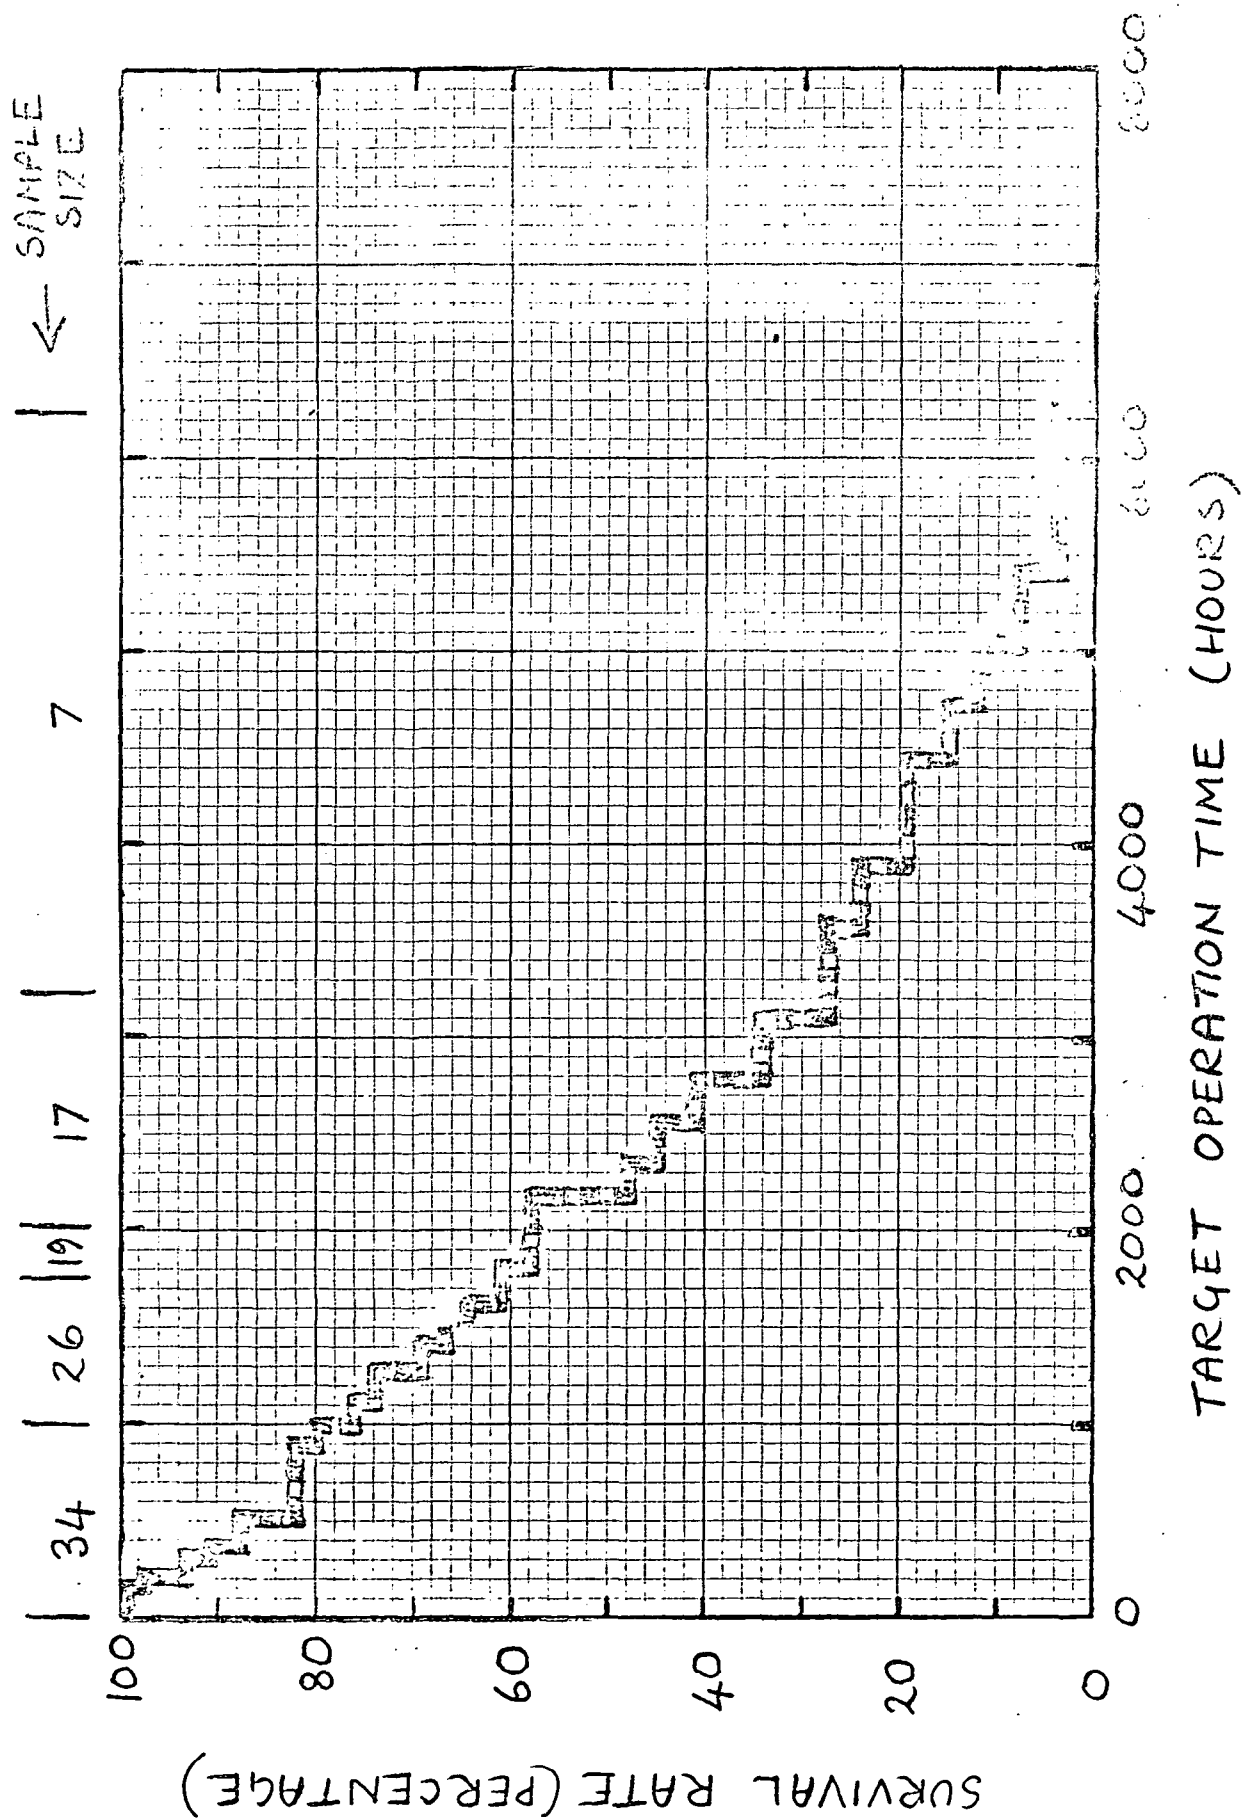
FIGURE 6.1

The SEC target life test data are listed in Figure 6.1. The end of life duration has been adjusted to reflect operation with an average signal current of 10 nA obtained with a 1/30 second integration time and 1/30 second frame time; that is, at normal TV rates. Deterioration

of the SEC target occurs only when the tube is exposed to light. The rate of deterioration is proportional to the light level or the signal current (since this is also proportional to light level). Thus, all of the life times shown in Figure 6.1 will be halved if the average signal current is increased to 20 nA. When using Figure 6.1, it should be noted that a scene consisting of half light (giving a 20 nA signal current) and half dark (giving a zero signal current) picture points will average to a 10 nA loading. Similarly a scene consisting of one-fifth light (giving a 25 nA signal current) and four-fifths dark (zero signal current) picture points will average to a 5 nA loading. In this latter case, the lifetimes shown in Figure 6.1 would be doubled.

To obtain these data, SEC camera tubes were operated in a dynamic life test set at recommended voltages and at an ambient temperature of about 28°C. The photocathode was exposed to a uniform illumination on the raster area. The tubes were periodically removed from the life test set and retested to check their performance. The tube performance was then compared to its performance before life test to determine whether the tube had failed.

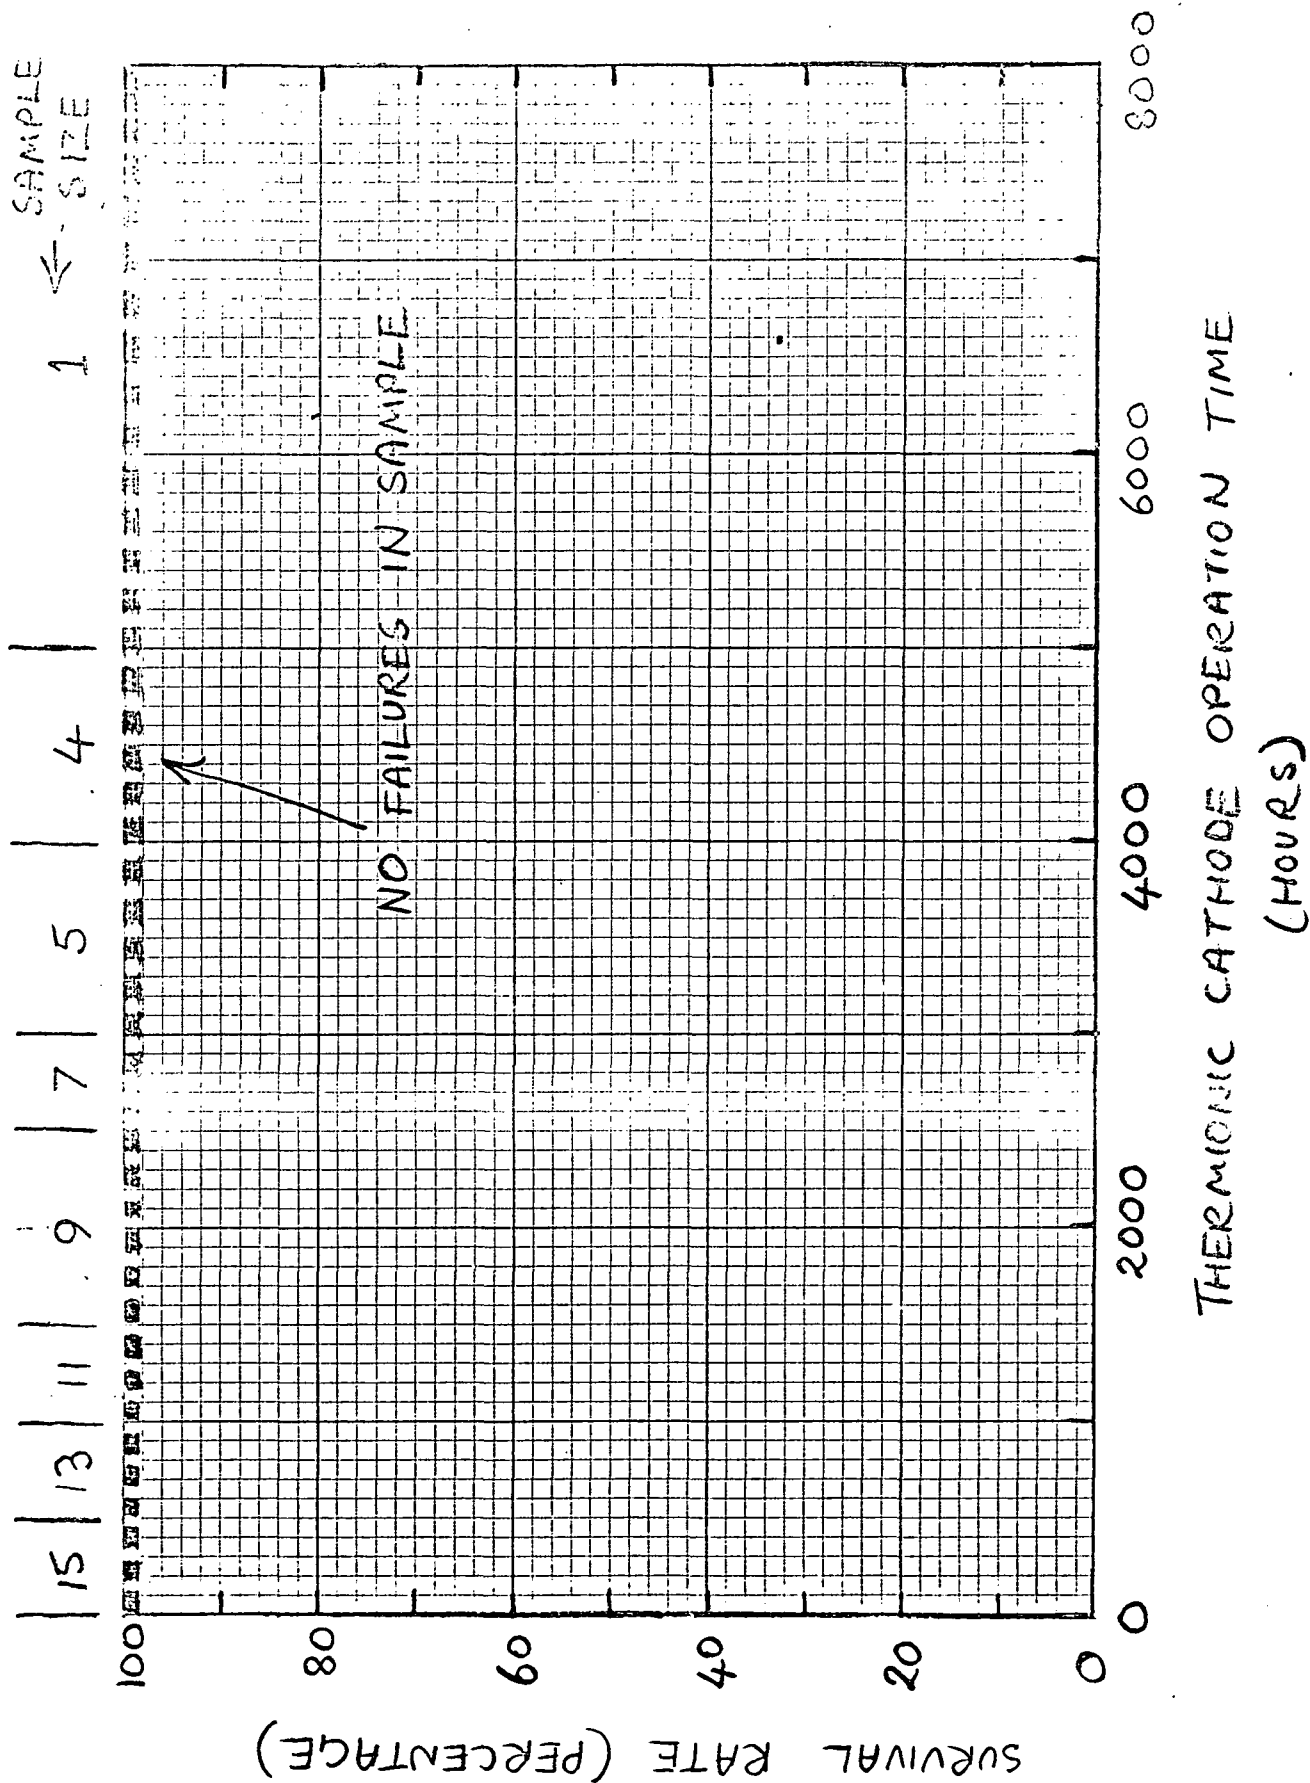
FIGURE 6.2

The thermionic cathode emission data are shown in Figure 6.2. SEC camera tubes were operated in a cathode life test set at an ambient temperature of about 28°C. The recommended voltages were applied to the cathode, the heater, and  $G_2$ .  $G_1$  bias was adjusted to give a 0.5 mA

cathode current. A 0.5 mA cathode current will easily discharge a 150 nA signal current. None of the other tube electrodes were connected. The tubes were periodically removed from the cathode life test set and retested to check their performance. The tubes' discharge capabilities were then compared to their performance before life test to determine whether the tubes had failed.

The performance of the thermionic cathode is very good, as can be seen from the lack of any failure on tubes tested to 8000 hours. Historically, the thermionic cathode has shown good performance on the tubes subjected to full operational life test; that is, tubes producing actual television pictures. Only one of the approximately thirty tubes tested has shown a cathode emission problem even before the cathode life was improved by reducing the cathode temperature.

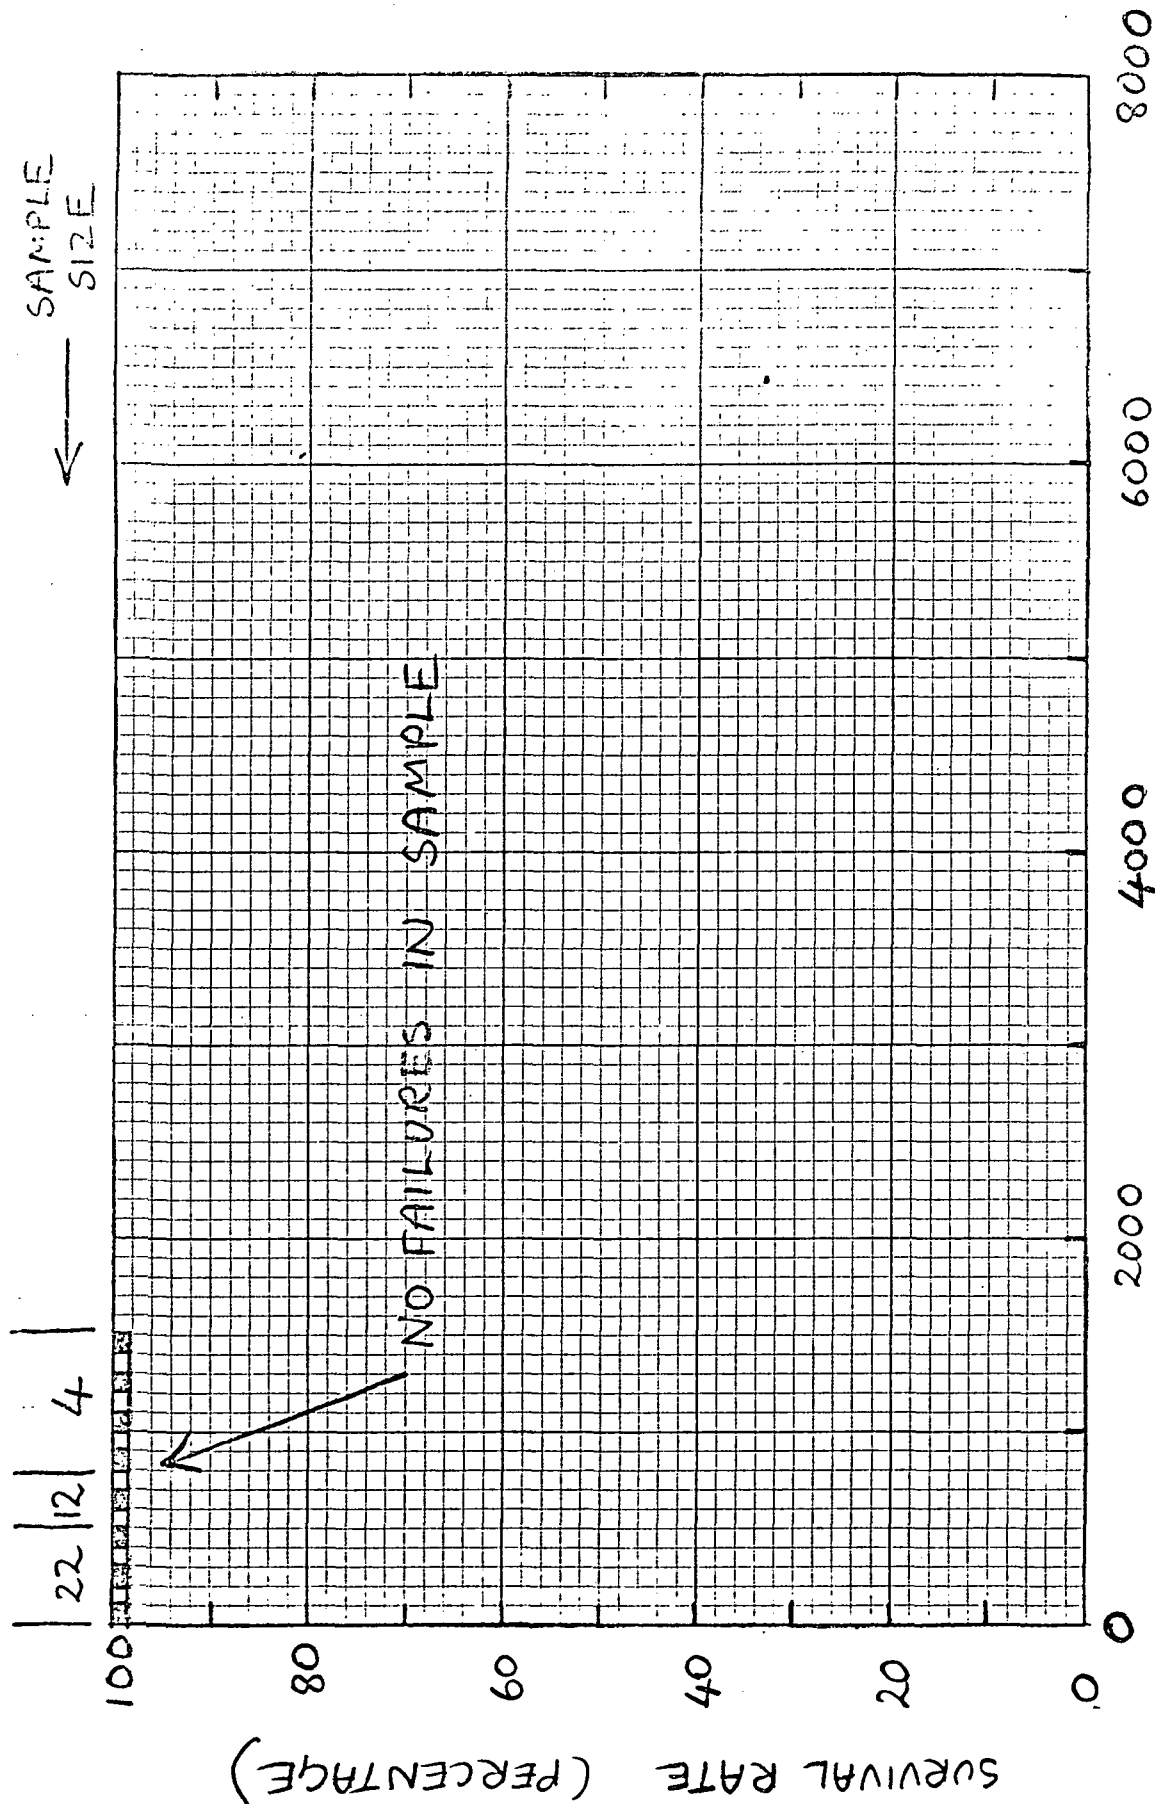
FIGURE 6.3

PHOTOCATHODE LIFE DURING FULL VIDEO OPERATION  
(HOURS)

1970 COMMERCIAL SEC CAMERA TUBES

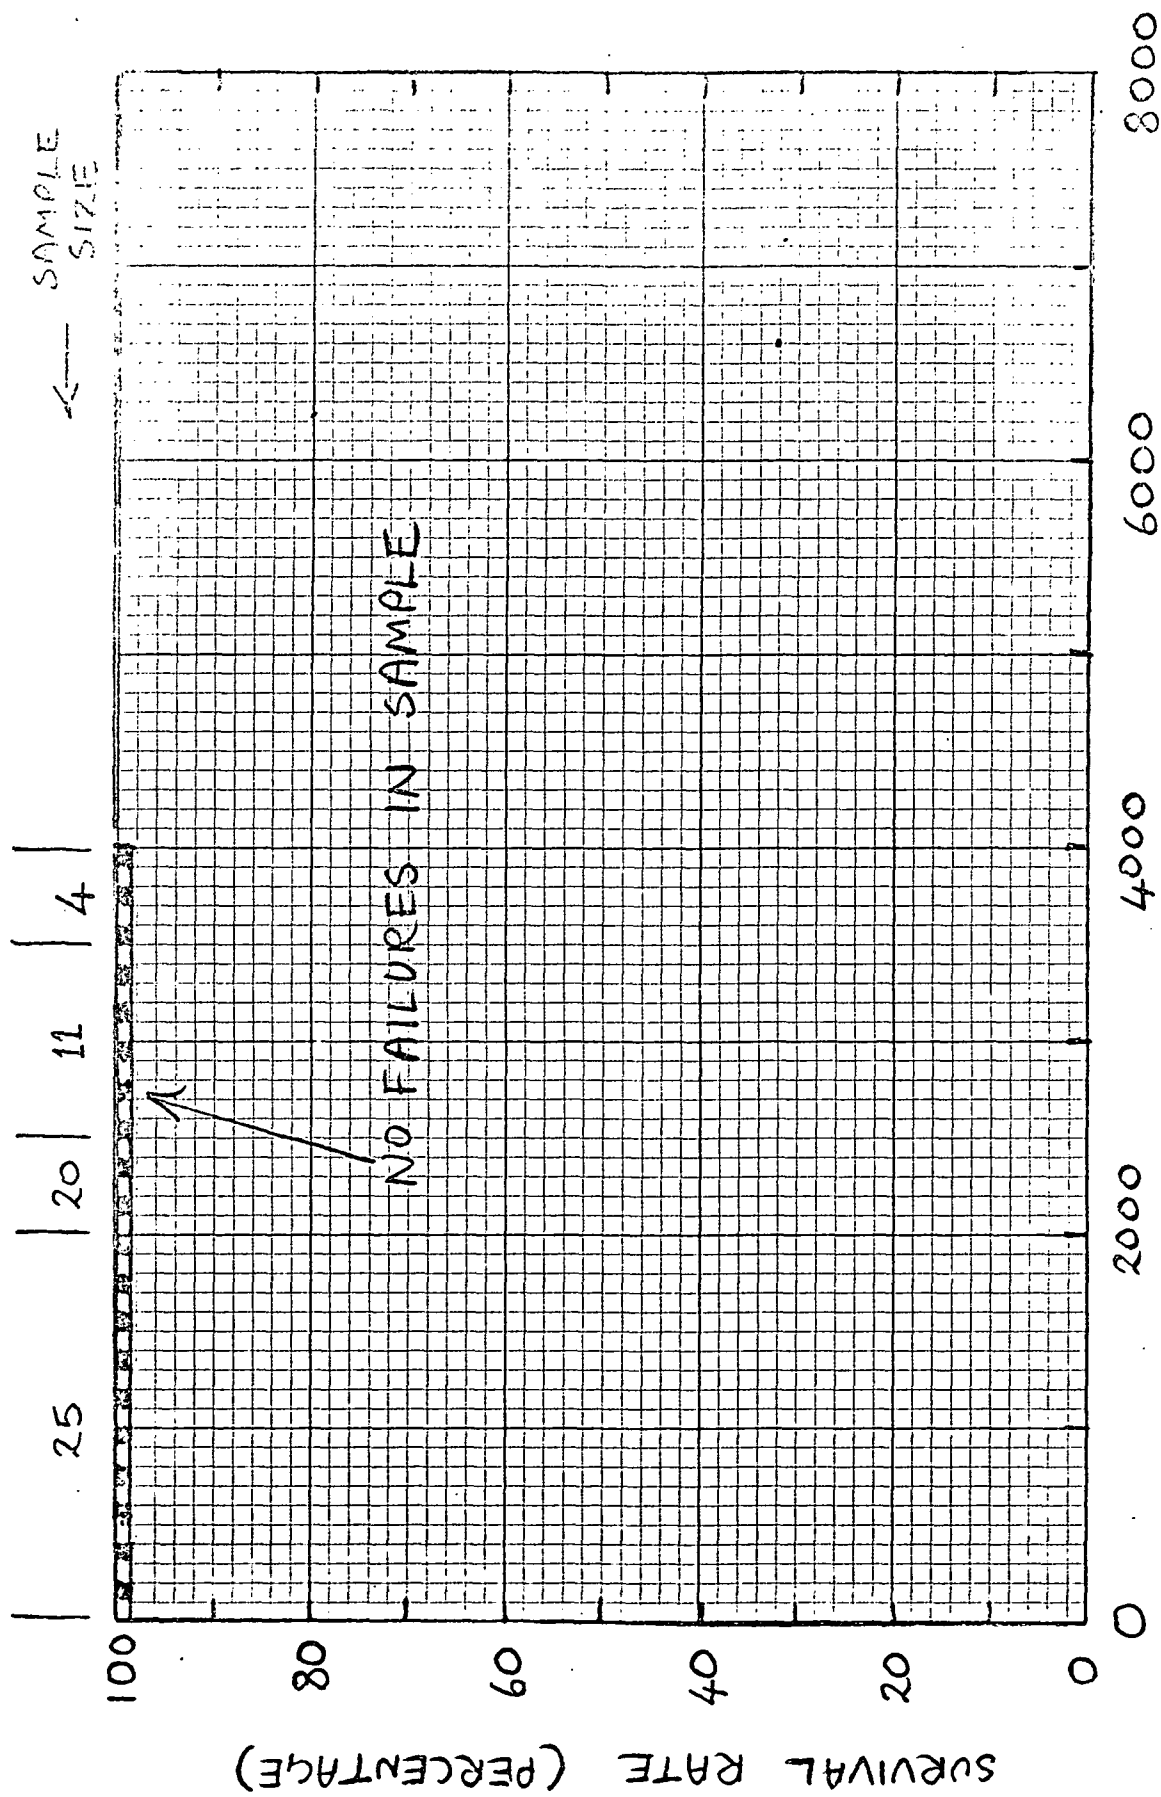
FIGURE 6.4

It may be concluded from the available data that a tube of the WX30691N type may experience a drop in photoresponse of approximately 15% over a four year period with a larger fraction of this drop occurring in the first year. It should be noted that, in some cases, techniques are available for the restoration of the photoresponse to close to its original value.

PHOTOCATHODE SHELF LIFE (HOURS)  
1972 WX-30691 N ATM TUBES

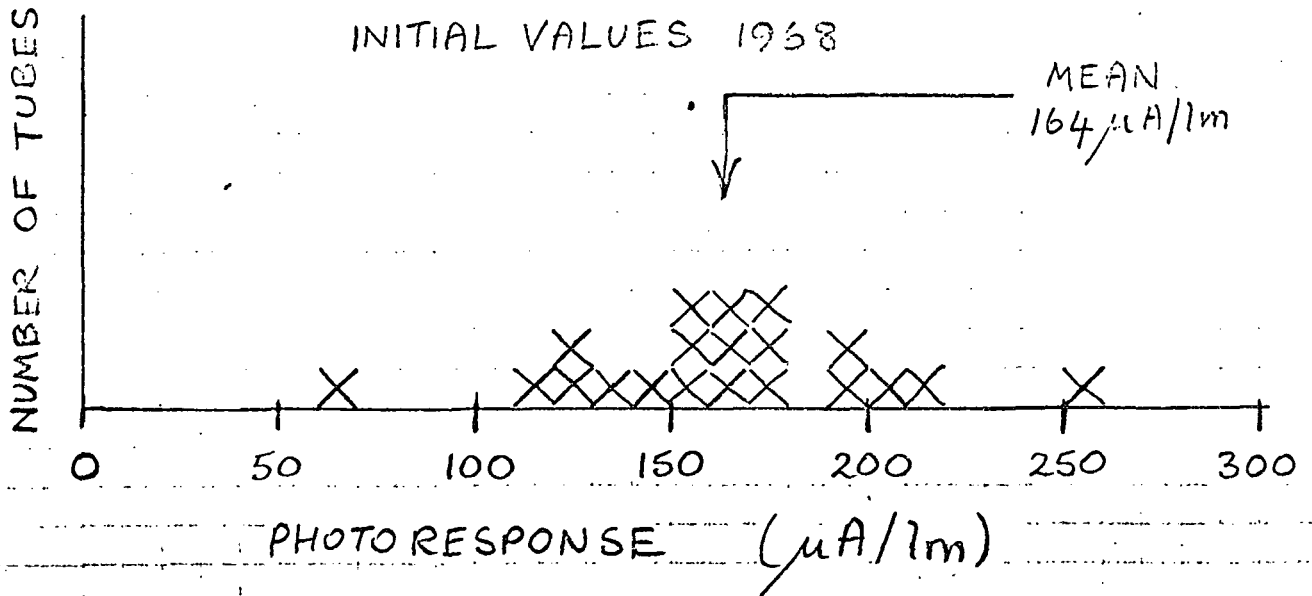
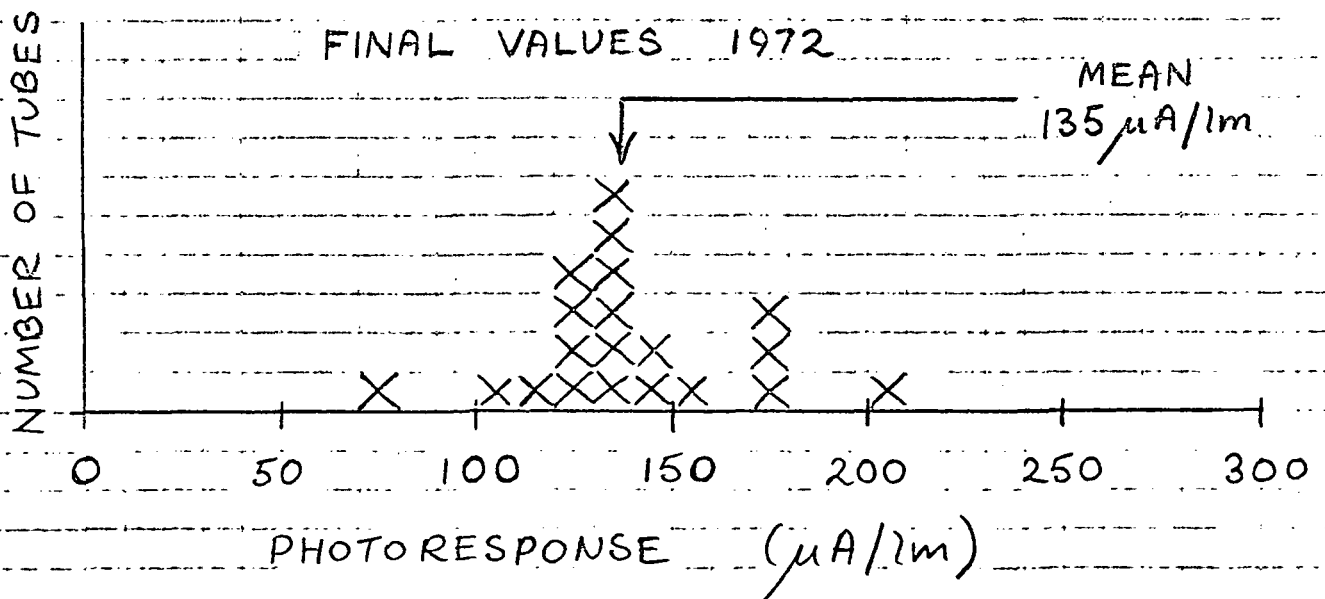
FIGURE 6.5

The average photoresponse for the sample dropped from 164  $\mu\text{A}/\text{lm}$  in 1968 to 138  $\mu\text{A}/\text{lm}$  in 1972. The average decrease calculated as a percentage of the initial photoresponse was 15%. Distributions of individual tube values for the sample as measured in 1968 and 1972 are shown in the form of histograms in Figure 6.5. The recorded values of photoresponse are shown as a function of time in Table 6.1.

# PHOTOCATHODE STABILITY FOR WX-30691N SEC TUBES MANUFACTURED IN 1968

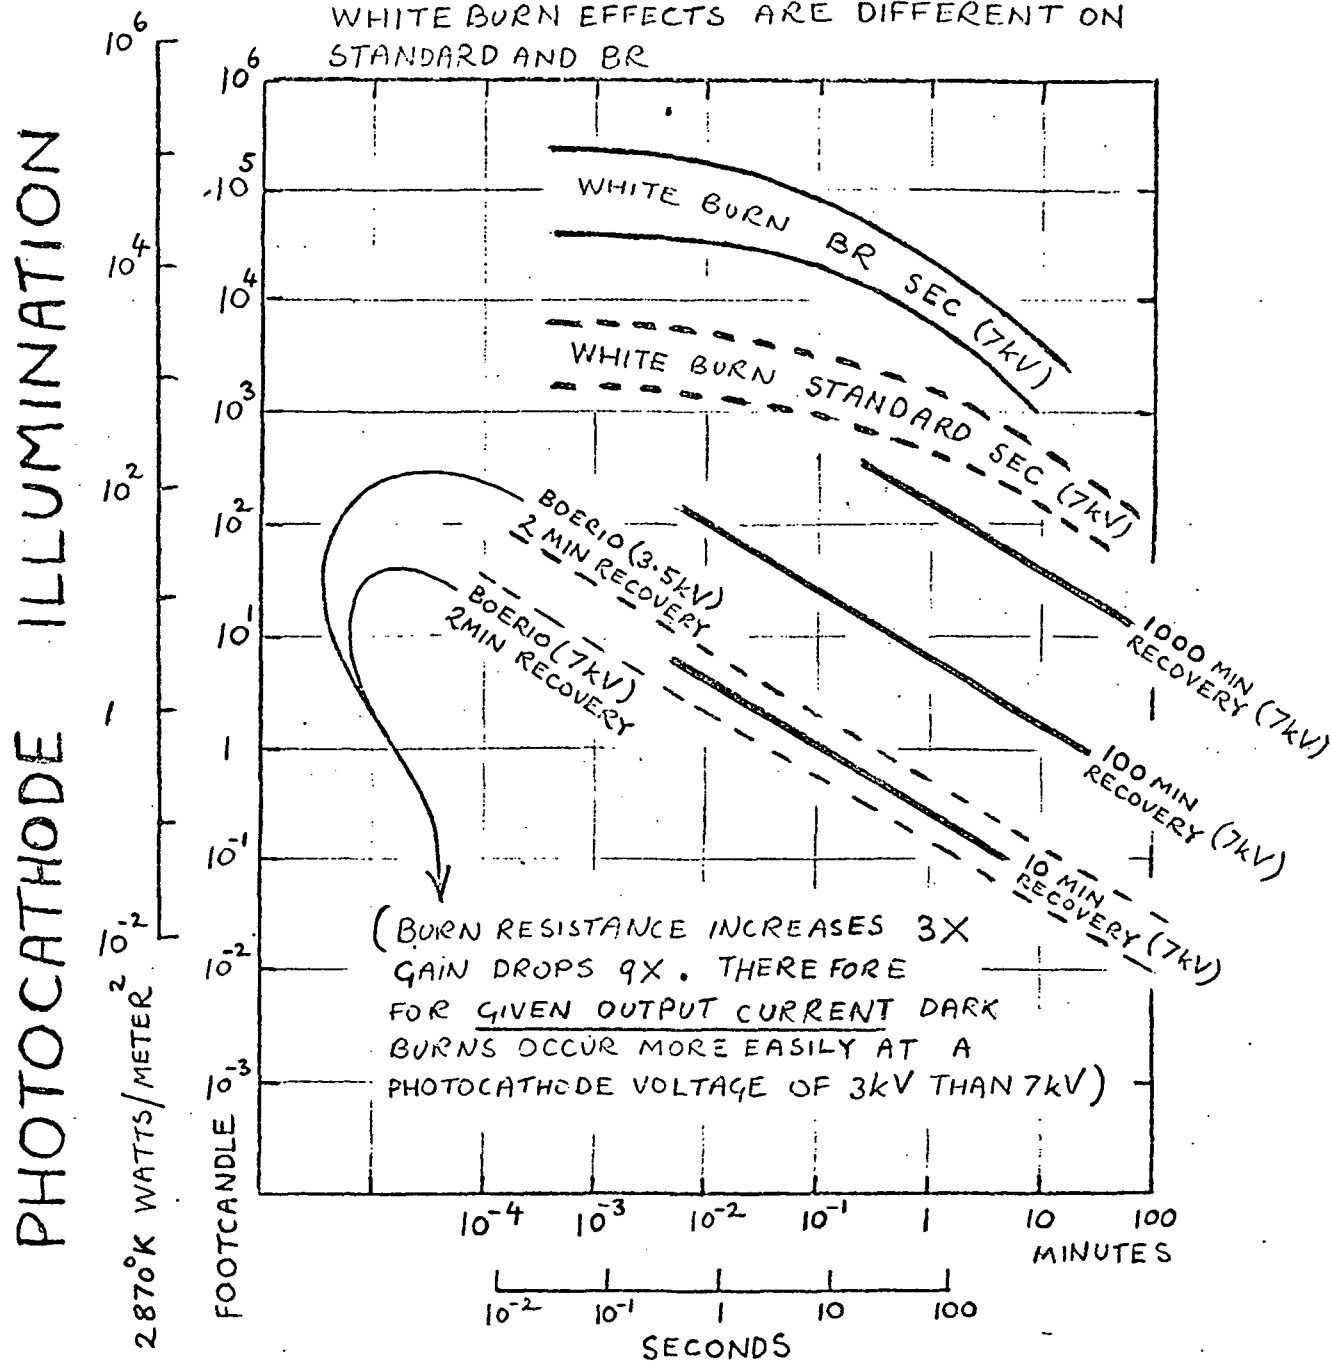
FIG 1

The results are summarized in Figure 1. This diagram shows the tolerance to different overload exposure illuminations and times for both white and dark burns. For example, consider an overload exposure of 10 minute duration. A  $10^{-1}$  footcandle overload will produce a dark burn that will recover in about 10 minutes. White burns (not recoverable) will be produced at 300 and 2000 footcandles respectively in the Standard and BR tubes. The dotted lines on the diagram show data reported earlier by Boerio. His dark burn information was for a 2 minute recovery. It is in fair agreement with the present measurements. Boerio made measurements at both 7 kV and 3.5 kV on the photocathode. Analysis of this data shows that for a given output signal current, burns occur 3 times more easily at 3.5 kV than at 7 kV.

DARK BURN EFFECTS ON STANDARD  
AND GR ARE SIMILAR

WHITE BURN EFFECTS ARE DIFFERENT ON  
STANDARD AND BR
